# Assessment of Dam Safety

## Coal Combustion Surface Impoundments (Task 3)

### Final Report

Progress Energy  
Carolinas  
Cape Fear Plant

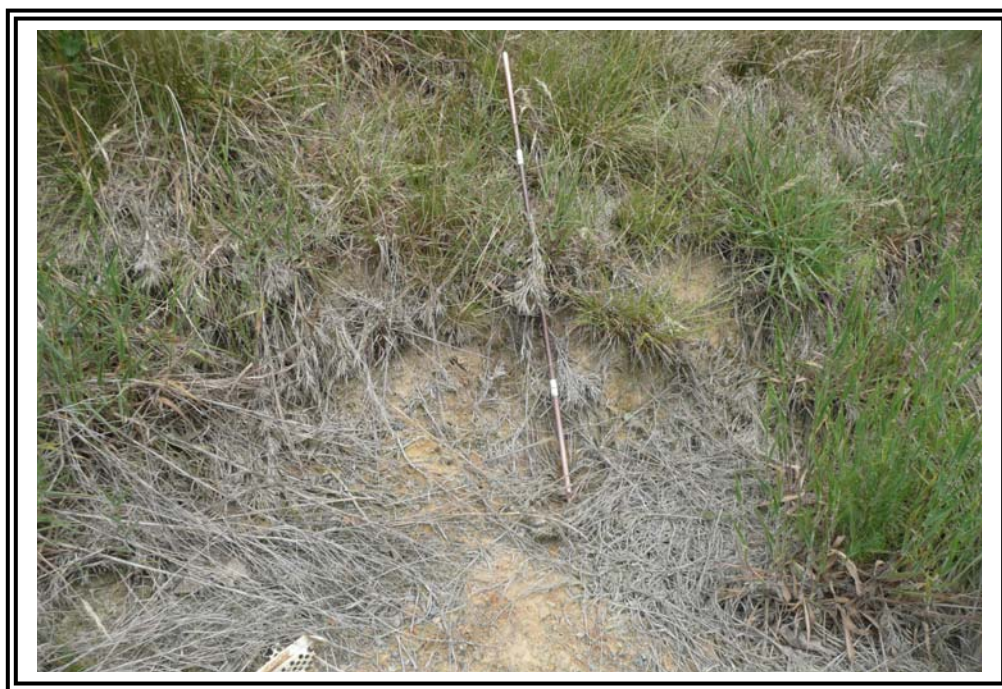
3

Erosion at the toe of the 1985 Ash Pond West Dike in an area of poor drainage.

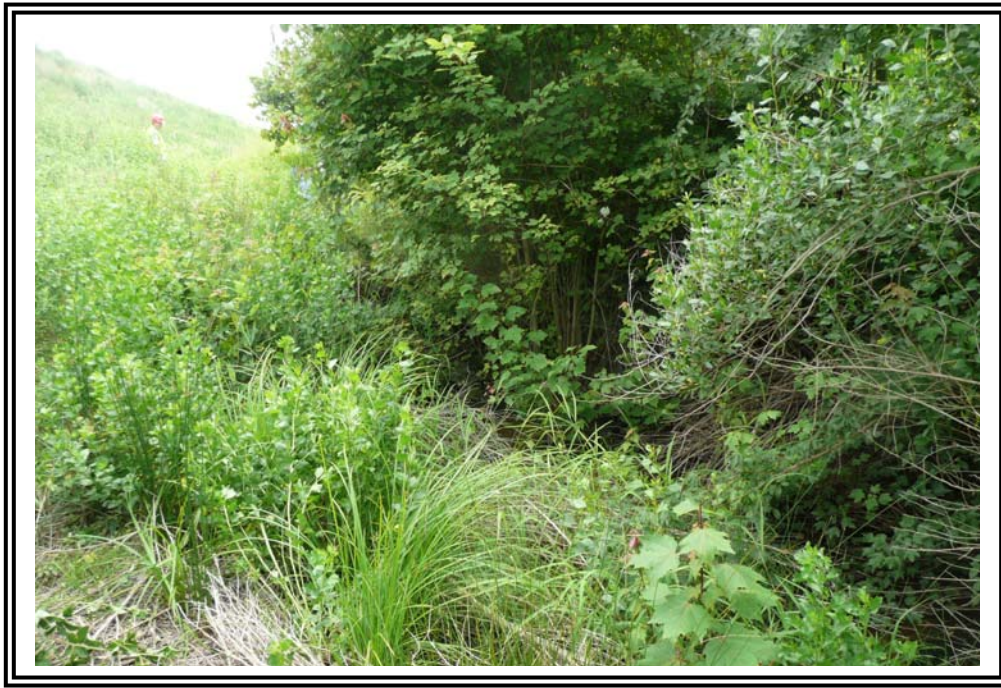
7

Tree growth at the toe of the 1985 Ash Pond West Dike.

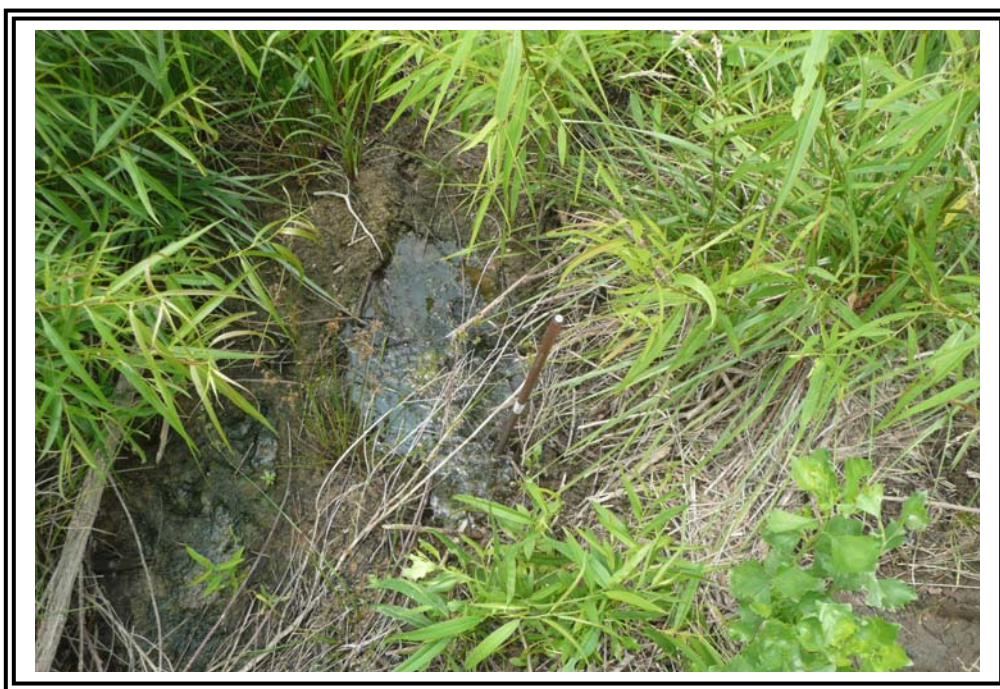
9

possible seepage was observed as shown in Photo 9. The drainage from this area which is at the southern end of the area in which water reportedly ponds passes into culverts under the access road and railroad tracks as shown in Photo 6.

Possible seepage at the toe of the 1985 Ash Pond West Dike.

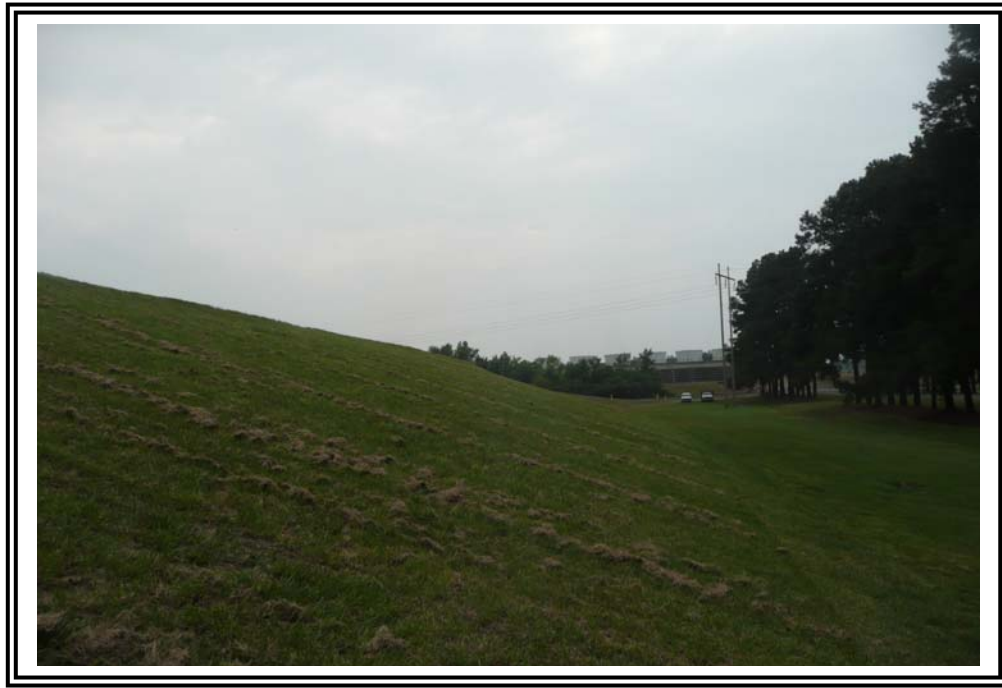
23

The downstream slope along the north dike is mowed, appropriate grass vegetation as shown in Photo 23. In this area, the downstream slope appeared uniform. A bare patch was observed just beyond the toe of the north dike as shown in Photo 22. Progress Energy Carolinas personnel indicated that they had recently observed this area and that they did not know of something having been placed in this area to cause the grass to die off.

North Dike of the 1985 Ash Pond, looking southwest.

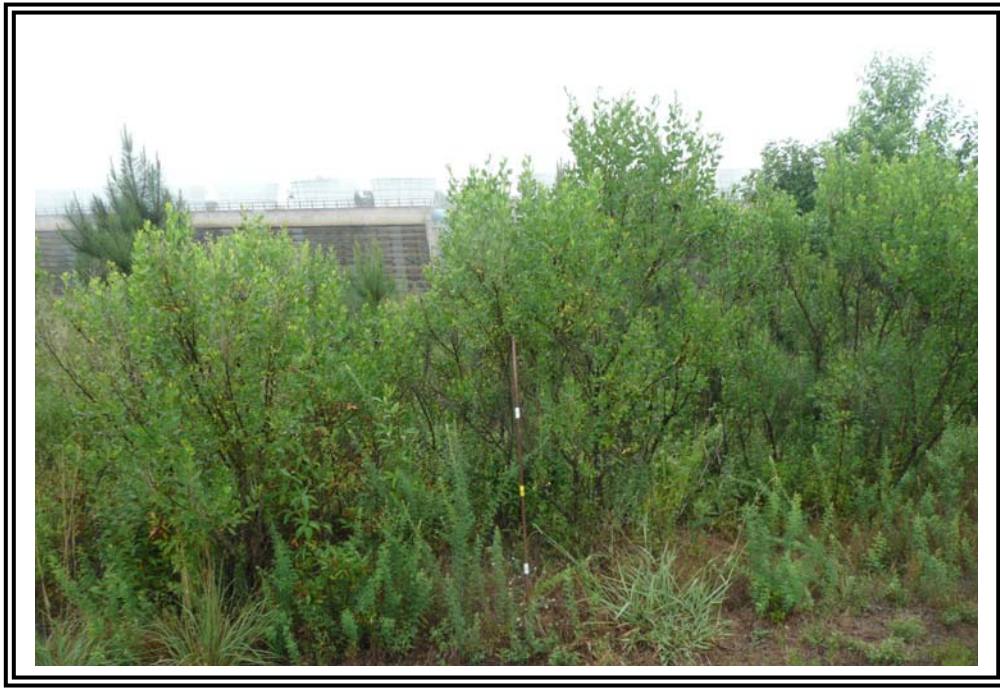
41

The crest alignment of the 1978 dikes do not appear changed from historic site plans. The 1978 Ash Pond contains water at the southern end of the pond and sluiced, but dried ash in the northern portion of the pond. In the northern portion of the pond, trees and other vegetation has established on the exposed ash as shown in Photo 66. Photos 41, 42, 45, and 50 show the typical vegetation conditions on the dikes.

North end of 1978 Ash Pond Dike, downstream slope is covered with large brush.

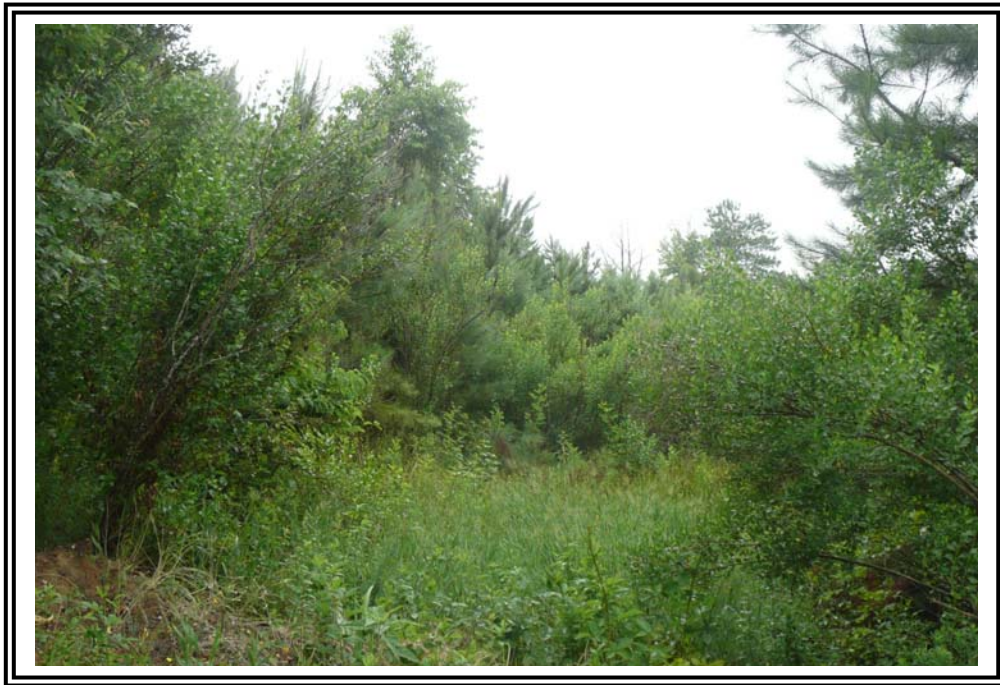
45

General vegetation conditions on the north end of the 1978 Ash Pond Dike downstream slope.

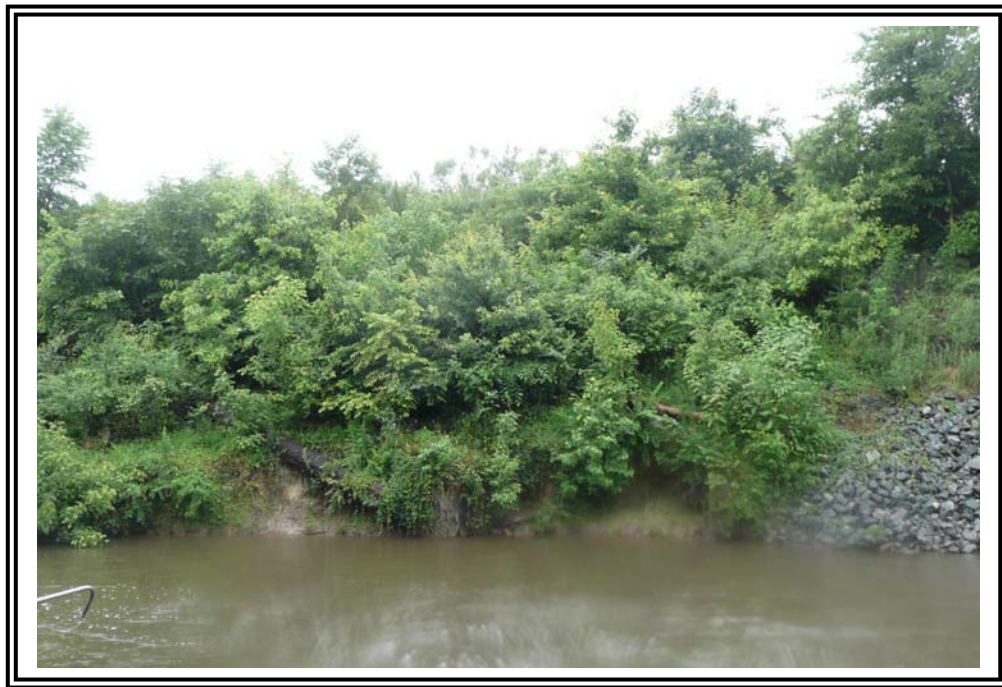
Along the easternmost portion of the dike where it parallels the Discharge Canal, undercutting of the dike toe from flows in the Discharge Channel in combination with fallen (uprooted) trees has resulted in sloughing of the slope. An area where a tree reportedly had uprooted was repaired in late 2006 or early 2007 with rip rap as shown in Photo 47. Photo 48 shows sloughing in this area and Photo 49 shows the undercutting of the toe from the Discharge Channel flows.

Erosion at the toe of the 1978 Ash Pond at discharge canal. Also note the fallen tree.

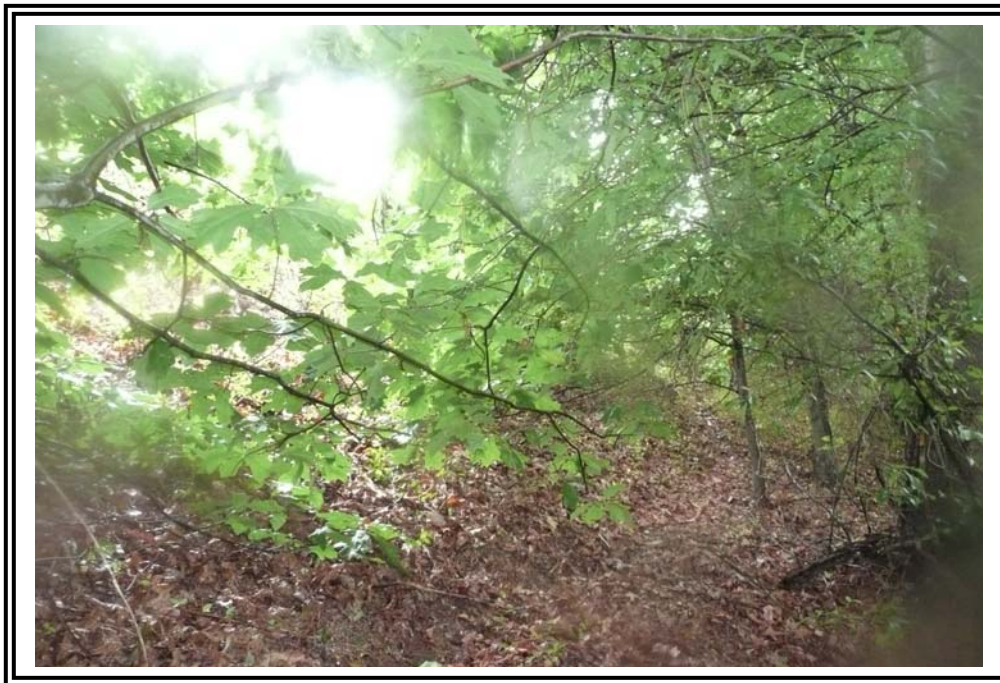
Slough on the downstream slope, east side of the 1978 Ash Pond Dike.

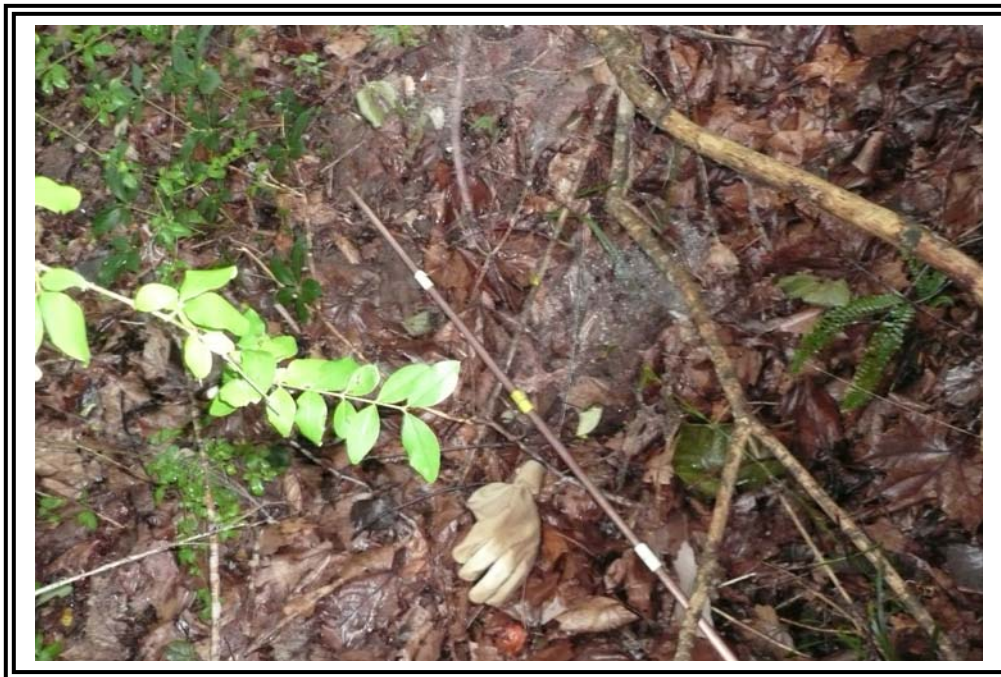
Erosion feature along 1970 Ash Pond west dike toe. Work glove placed below 4' probing rod supported at edge of feature for scale purposes.

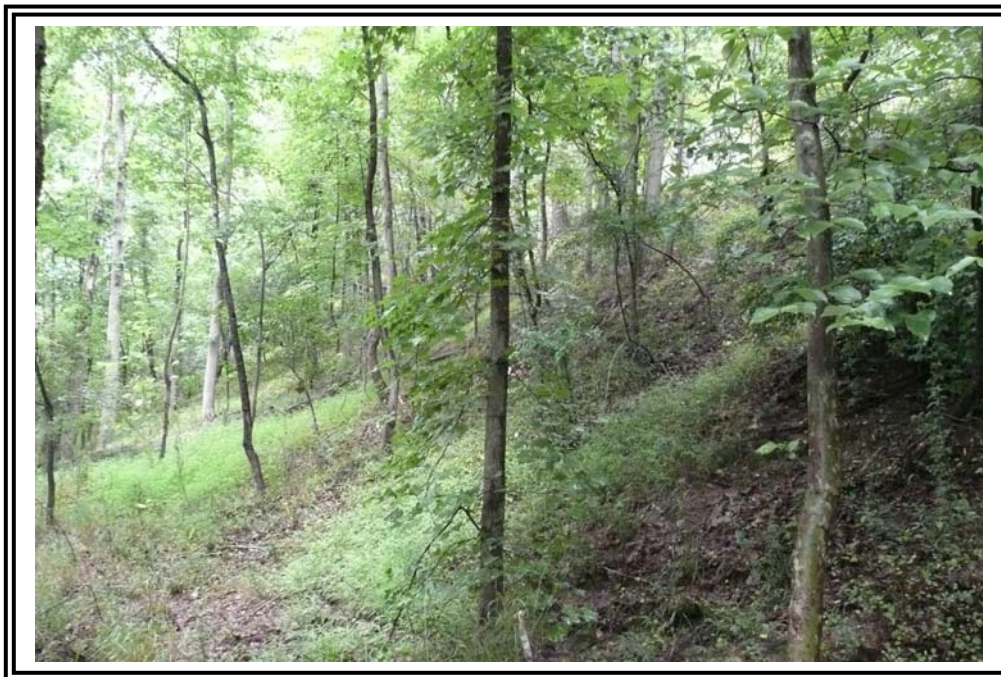
86

Steepened conditions on 1963 Ash Pond west dike from surface erosion and sloughing.

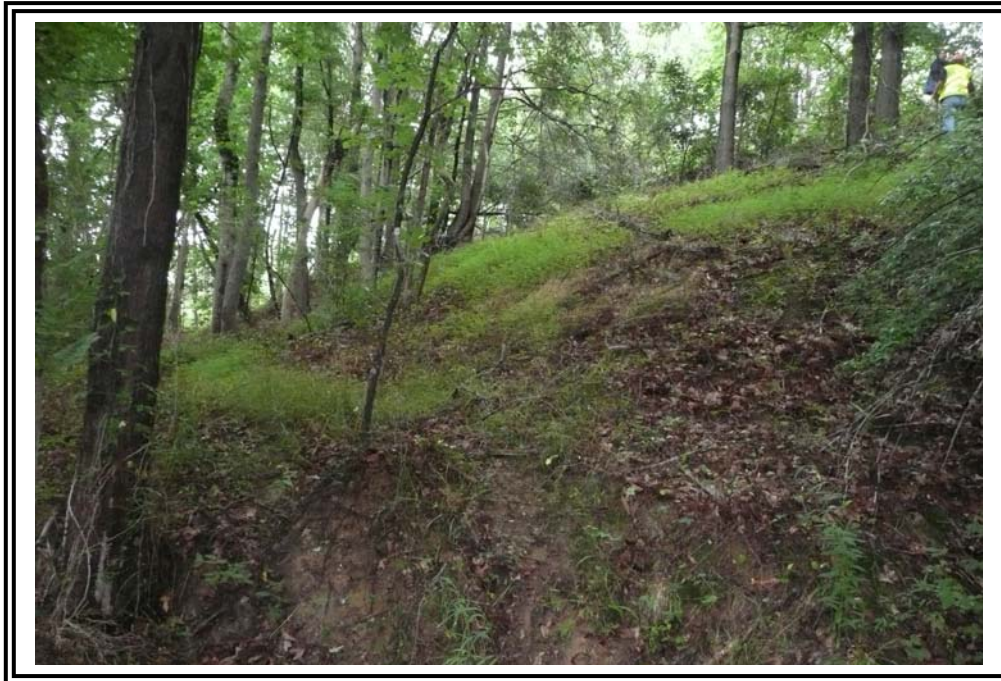
87

Steepened conditions on 1963 Ash Pond west dike from surface erosion and sloughing.

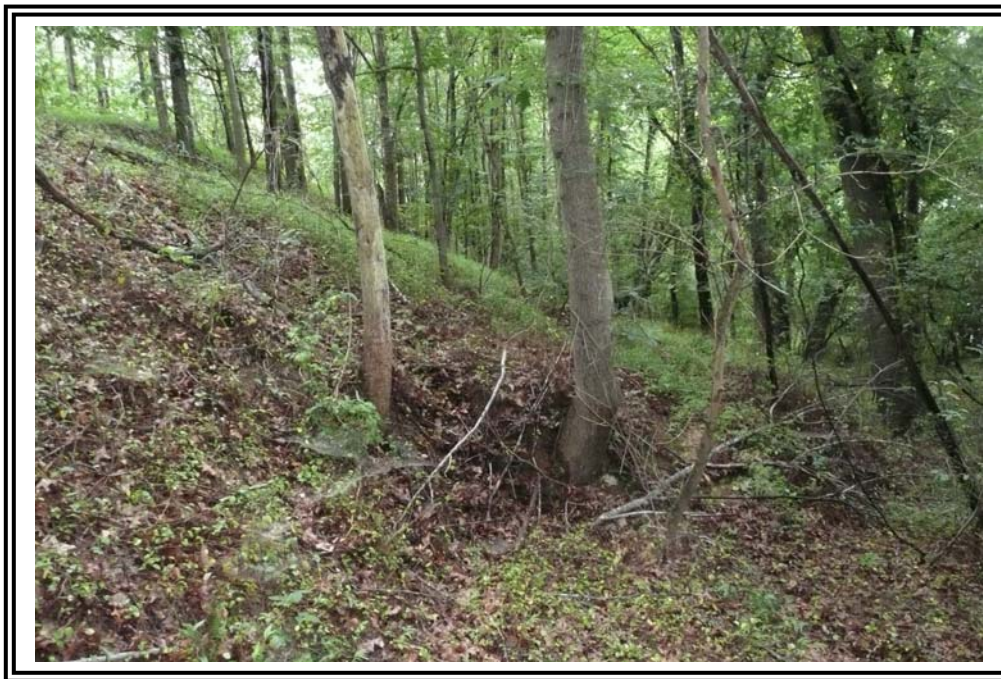
In 1982, a slope failure occurred on the north end of the west dike in the 1963/1970 ash pond adjacent to the Cape Fear River. According Progress Energy Carolinas' engineering consultant (MACTEC), at that time it was proposed to repair the failure with a rip-rap berm placed at the dike toe on the banks of the river channel. As the repair was being implemented, construction activity initiated additional instability and deformation (possibly localized vibratory induced liquefaction) and the work was halted with only a portion of the proposed rip-rap being placed at the river's edge and base of the dike. An independent engineering review and analysis of the failure was completed after the partial repair construction was halted and concluded that the dike was acceptable because the pond had been inactive since 1970 and the dike was impounding mostly sedimented ash.

Steepened conditions on 1963 Ash Pond west dike from surface erosion and sloughing from the partially repaired 1982 slide.

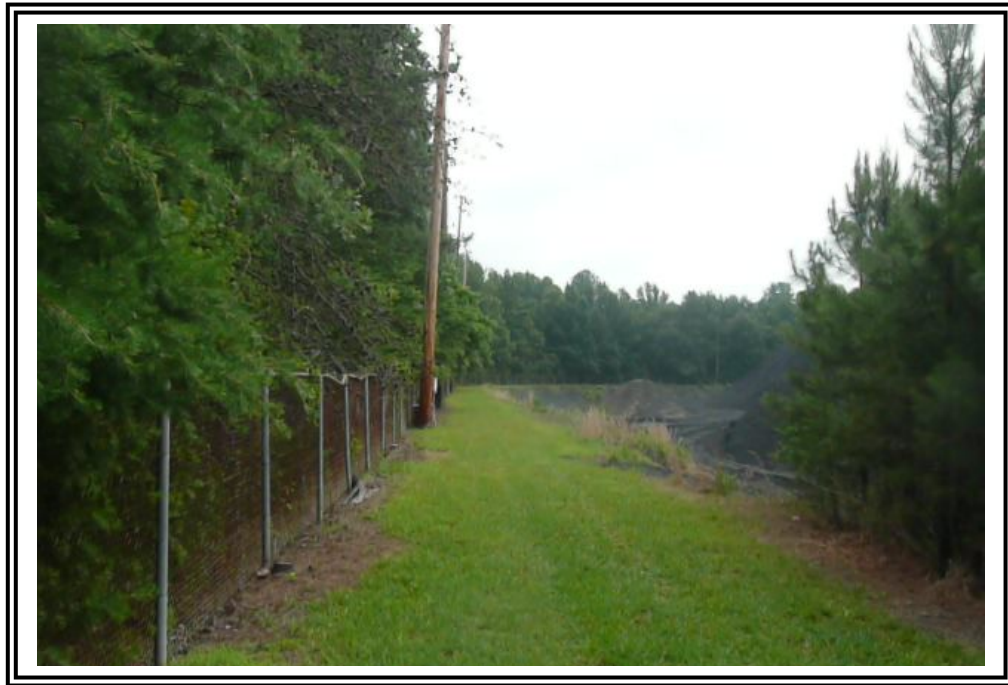
The south dike of the 1956 Ash Pond is a portion of a flood control levee system that was installed around the plant to protect it from flooding from the Cape Fear River. As noted in Section 1.3 the construction of B. Everett Jordan Dam has resulted in this levee system to not be required. Photos 92 and 93 show this south dike of the 1956 Ash Pond. The ash pond is

Flood control dike which contained the south side of the 1956 Ash Pond, looking northeast.

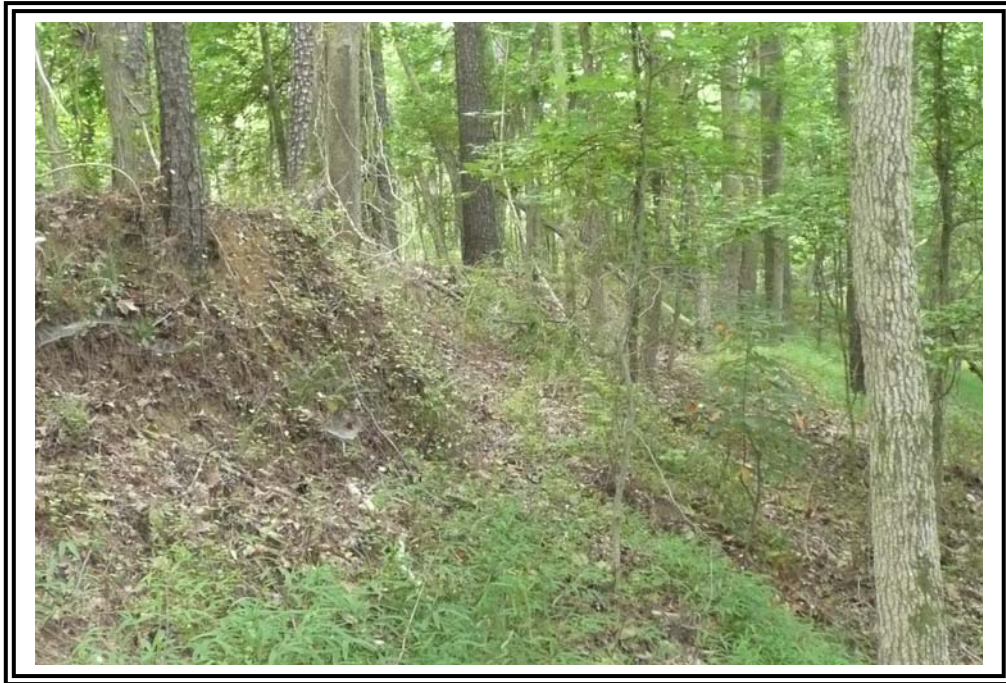
Along the northwest to east sides of the 1956 Ash Pond there is 3 to 8 feet of freeboard between the top of the deposited ash and the crest of the dikes. The downstream slopes are severely eroded, have experienced fallen (uprooted) trees, and sloughing. Examples of these conditions and the resulting steepening of the downstream slopes are shown in Photos 98 through 101, and 103.

Typical of frequent areas of erosion on the downstream slopes of the 1956 Ash Pond Dikes.

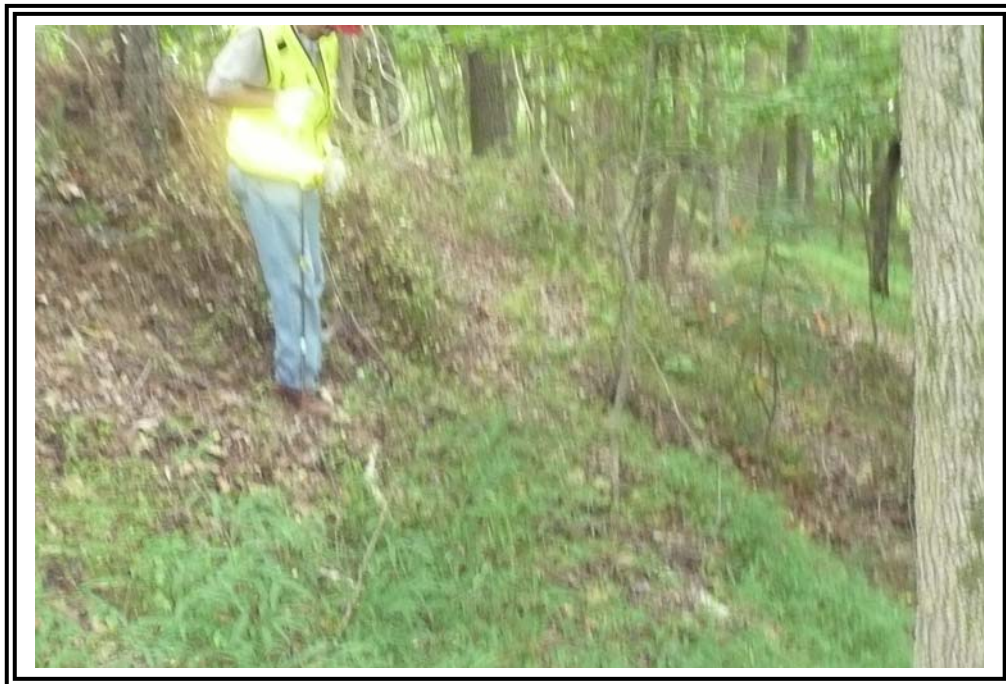
Same location as the previous photo with a person for scale.

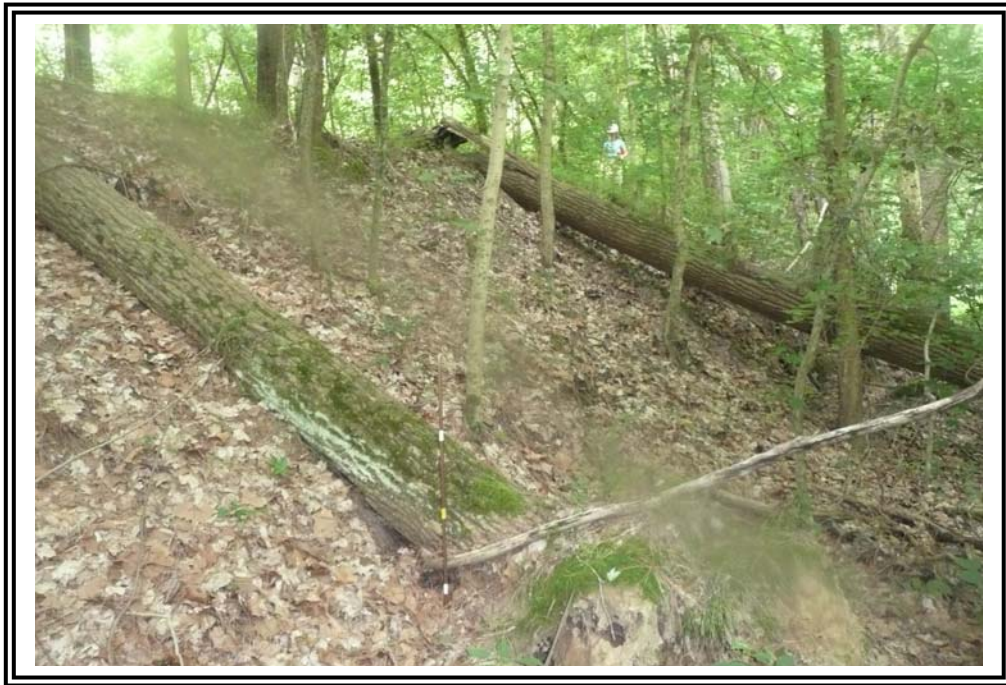
100

Typical size of fallen trees on the 1956 Ash Pond Dike slopes.
